Reserve Study Update

The Reserve Study for Kinderton Village Residential Homeowners Master Association, Inc.
Was submitted onDecember 5, 2012

CONDITION ASSESSMENT

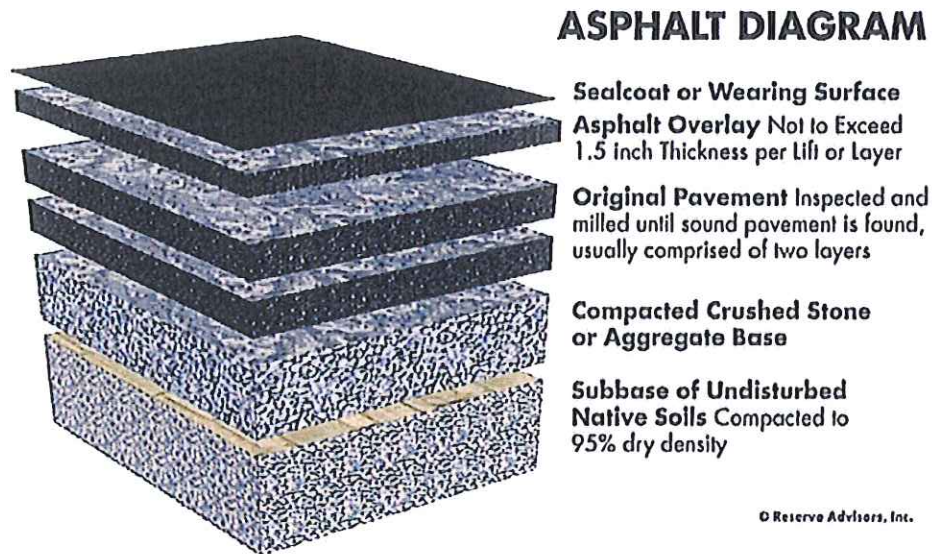
Components of asphalt pavement include native soil, aggregate and asphalt. First the contractor creates a base course of aggregate or crushed stone and native soil. The base course is individually compacted to ninety-five percent (95%) dry density prior to the application of the asphalt. Compaction assures a stable base for the asphalt that reduces the possibility of settlement. The initial installation of asphalt uses at least two lifts, or two separate applications of asphalt, over the base course. The first lift is the binder course. The second lift is the wearing course. The wearing course comprises a finer aggregate for a smoother more watertight finish. The following diagram depicts these components.

The *manner of repaving* is either a *mill and overlay* or *total replacement*. A mill and overlay is a method of repaving where cracked, worn and failed pavement is mechanically removed or milled until sound pavement is found. A new layer of asphalt is overlaid atop the remaining base course of pavement. Total replacement includes the removal of all existing asphalt down to the base course of aggregate and native soil followed by the application of two or more new lifts of asphalt. We recommend mill and overlayment on asphalt pavement that exhibits normal deterioration and wear. We recommend total replacement of asphalt pavement that exhibits severe deterioration, inadequate drainage, pavement that has been overlaid multiple times in the past or where the configuration makes overlayment not possible. Based on the apparent visual condition and configuration of the asphalt pavement, we recommend the *mill and overlay* method for initial repaving and the *total replacement* method for subsequent repaving at KVRHMA.

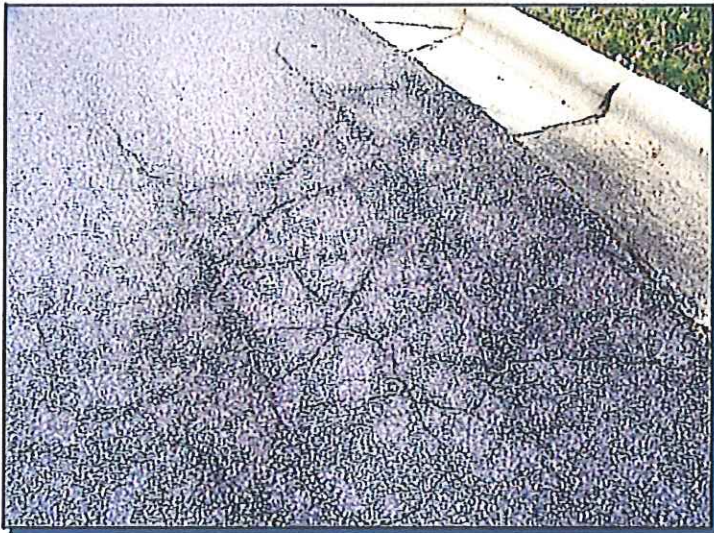
Pavement cracks and deterioration

KVRHMA should repair any isolated areas of deteriorated pavement prior to seal coat applications. Proposals for seal coat applications should include both crack repair and area patching. These activities reduce water infiltration and the effects of inclement weather. The contractor should only apply seal coat applications after remedial crack and surface repairs are completed. A seal coat does not bridge or close cracks, therefore, unrepaired cracks render the seal coat applications useless. Our future estimates of cost include an allowance for both crack repair and area patching.

We recommend that KVRHMA plan the next application of seal coat in 2013 and subsequent applications every four years thereafter except when repaving occurs. Line Item 4.020 of *Reserve Expenditures* notes our estimate of future costs and anticipated times of seal coat applications. Our costs include allowances for striping of the parking areas.

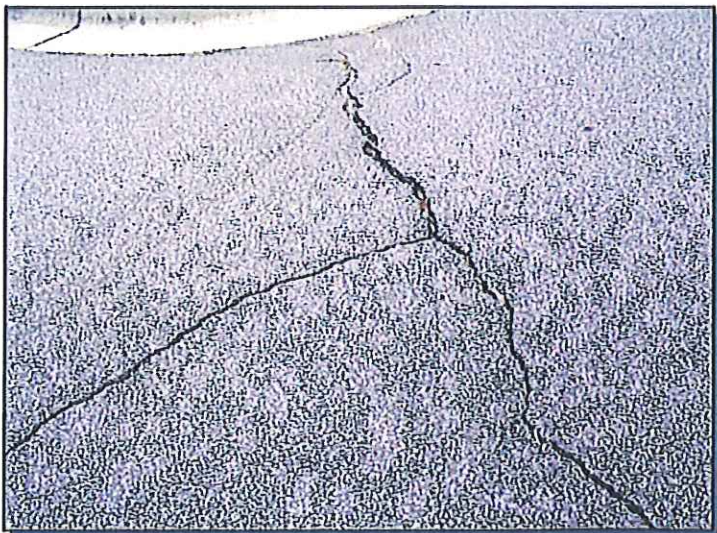
Pavement cracks

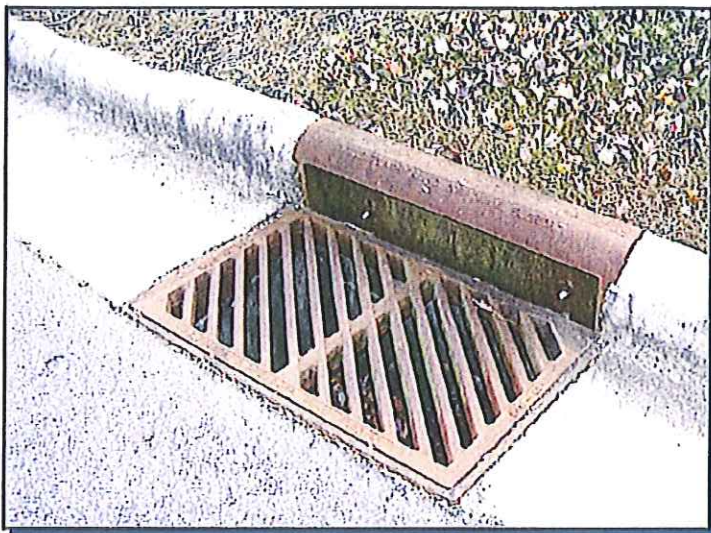
Catch Basins - Four catch basins collect storm water from the parking lot and access drive pavement and conduct it into the storm water system. The overall condition of the catch basins is good without settlement visually apparent. The useful life of catch basins is up to 60 years. However, achieving this useful life usually requires interim capital repairs or partial replacements every 15- to 20-years.

Catch basin

catch basins, we recommend the Association anticipate the inspection, capital repair or partial replacement of the four catch basins in conjunction with each repaving event. We include this information on Line Item 4.100 of *Reserve Expenditures*.

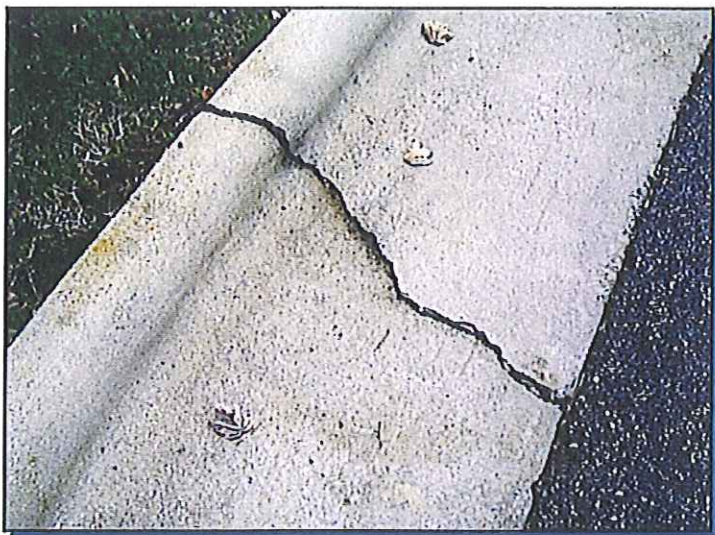
Concrete Curbs and Gutters - Concrete curbs and gutters line the access drive and parking lot pavement of KVRHMA. These curbs and gutters comprise 1,450 linear feet and are in good condition overall. We note isolated cracks. An example is shown on Page 5.3 of *Photographs* depicts this condition. This application of concrete has a useful life of up to 65 years although isolated deterioration of limited areas of concrete is common. Inclement weather, inadequate subsurface preparation and improper concrete mixtures or finishing techniques can result in premature deterioration such as settlement, chips, cracks and spalls. Variable conditions like these result in the need to plan for periodic partial replacements of the concrete flatwork throughout the next 30 years. We estimate that up to 145 linear feet of curbs and gutters, or ten percent (10%) of the total, will require replacement by 2021, 2029 and 2039. We depict this information on Line Item 4.110 of *Reserve Expenditures*. The Association should coordinate partial replacements of concrete curbs and gutters with asphalt pavement, due to the interrelated nature of these items. The times and costs of these replacements may vary. However, the estimated expenditures detailed in *Reserve Expenditures* are sufficient to budget appropriate reserves.

Concrete curb crack and
settlement

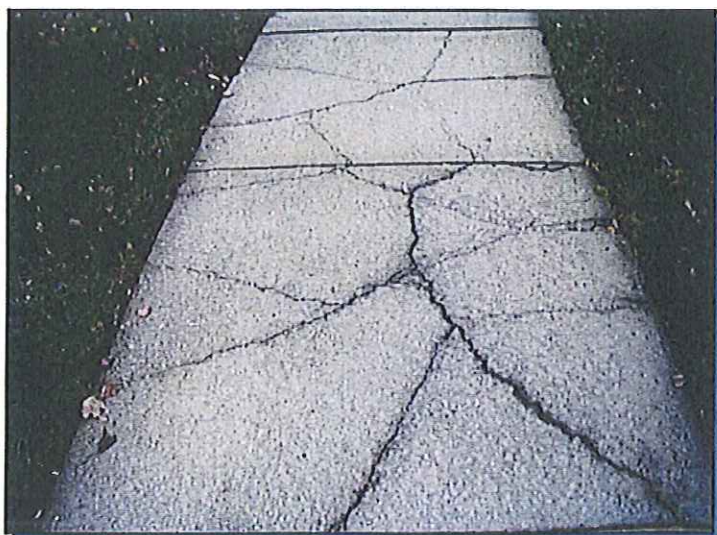
Concrete sidewalk cracks

*Note: The Association should fund
concrete sidewalk partial
replacements through the
operating budget*

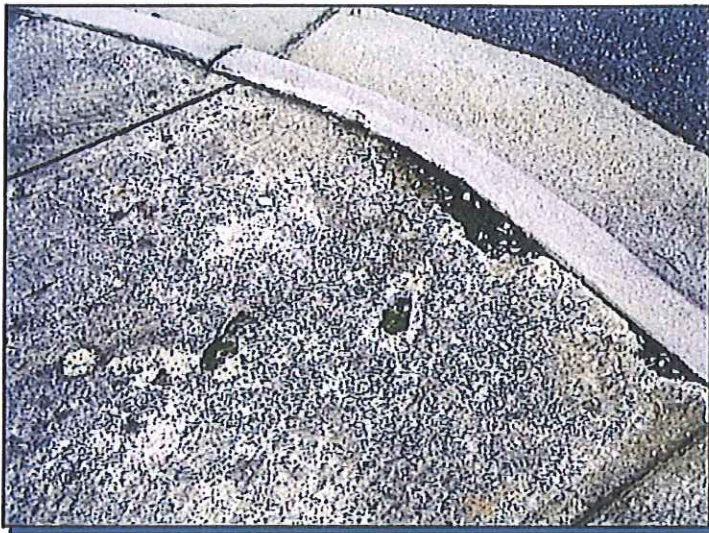
Concrete sidewalk deterioration

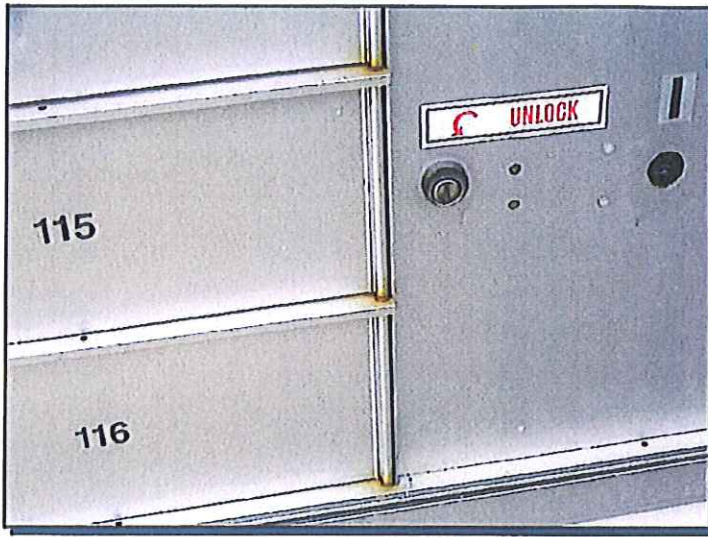
Mailboxes, Metal - A total of eight mailbox kiosks throughout the property contain the individual mailboxes that serve the sub-associations. Management informs us the municipality is responsible for the structures. The metal mailboxes are in original, in good overall condition and have a useful life of up to 25 years. We note isolated mailbox rust as shown on Page 5.5 of *Photographs*. KVRHMA should budget for replacement of the mailboxes by 2023. We depict this information on Line Item 4.600 of *Reserve Expenditures*. The Association should verify the new mailboxes meet the specifications of the United States Postal Service.

Mailbox station rust

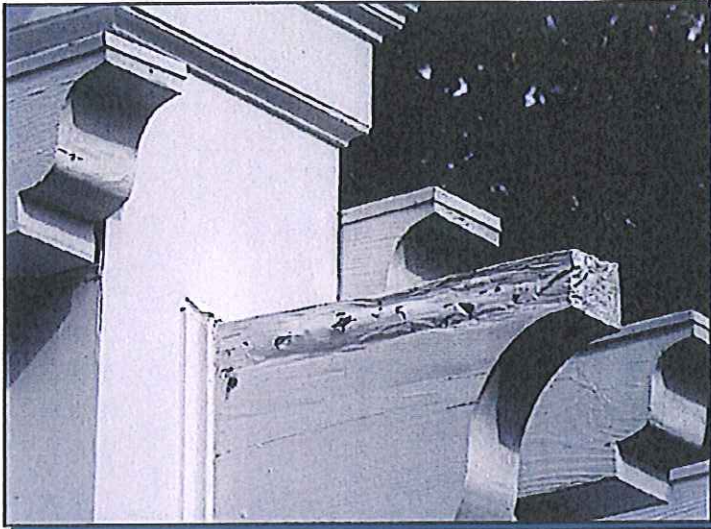
Ramadas - The Association maintains three ramadas at the common areas. The ramadas are original and in good condition. We note paint finish deterioration and wood rot as shown on Page 5.8 of *Photographs*. The Association should fund paint finishes and repairs through the operating budget. Wood structures exposed to weather have a useful life of up to 25 years. We recommend KVRHMA budget for replacement by 2023. We depict this information on Line Item 4.733 of *Reserve Expenditures*.

Wood rot and paint finish deterioration

Note: The Association should fund paint finishes and repairs through the operating budget

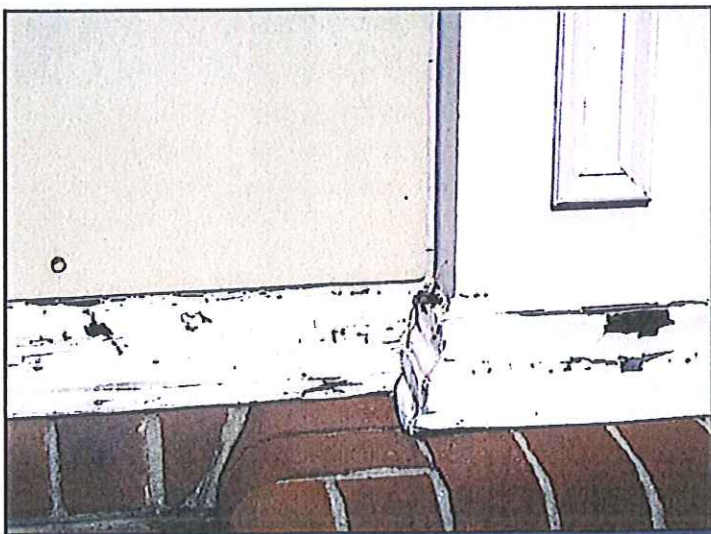
and in good condition. However, we note wood rot beneath the entrance sign as shown on Page 5.8 of *Photographs*. The Association should fund paint finishes and repairs through the operating budget. Community signage contributes to the overall aesthetic appearance to owners and potential buyers. Renovation or replacement of community signs is often predicated upon the desire to "update" the perceived identity of the community rather than for utilitarian concerns. Therefore, the specific times for replacement or renovation are discretionary. We recommend the Association plan to renovate the signage every 15- to 20-years, or by 2018 and 2036. Renovation should include the following work:

Wood rot beneath entrance sign

We note this information on Line Item 4.800 of *Reserve Expenditures*. The Association should fund interim repairs and replacements through the operating budget.

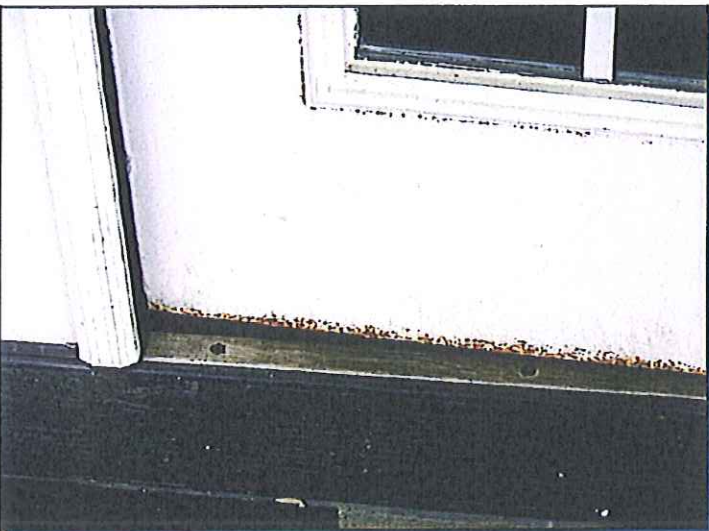
Door rust

Note: The Association should fund clubhouse door replacements through the operating budget

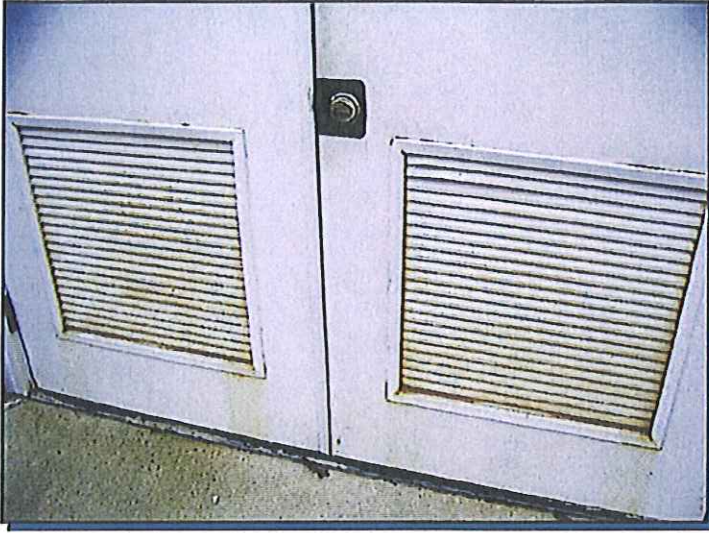
Pool mechanical room door rust

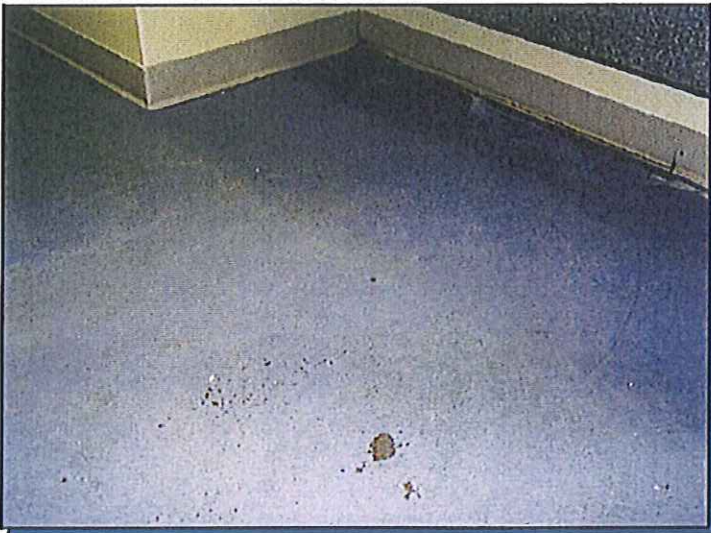
Concrete floor paint finish
deterioration

*Note: The Association should fund
interim paint finishes through the
operating budget*

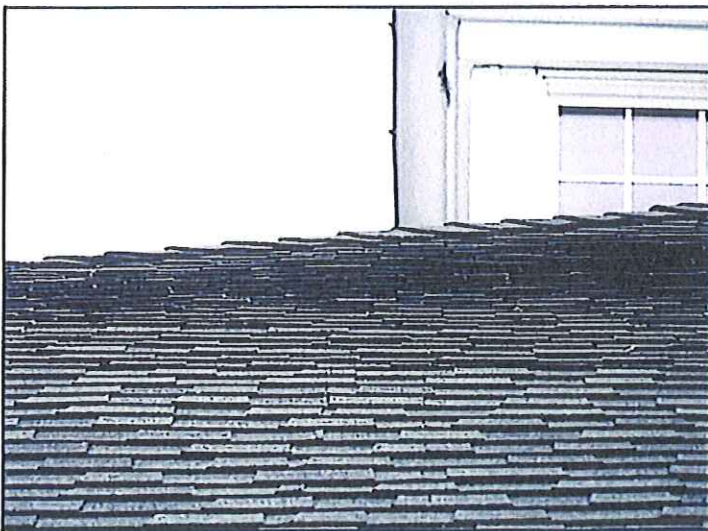
Roof Assembly, Asphalt Shingles - The clubhouse roof assembly comprises 35 *squares*² of asphalt shingles and 280 linear feet of gutters and downspouts. The roof is original and in good condition. We note sheathing deflection as shown on Page 5.11 of *Photographs*. The useful life of an asphalt shingle roof is from 15- to 20-years. We recommend the Association

Sheathing deflection

anticipate complete replacement of the clubhouse roof by 2022 and again by 2041. We note this information on Line Item 5.600 of *Reserve Expenditures*.

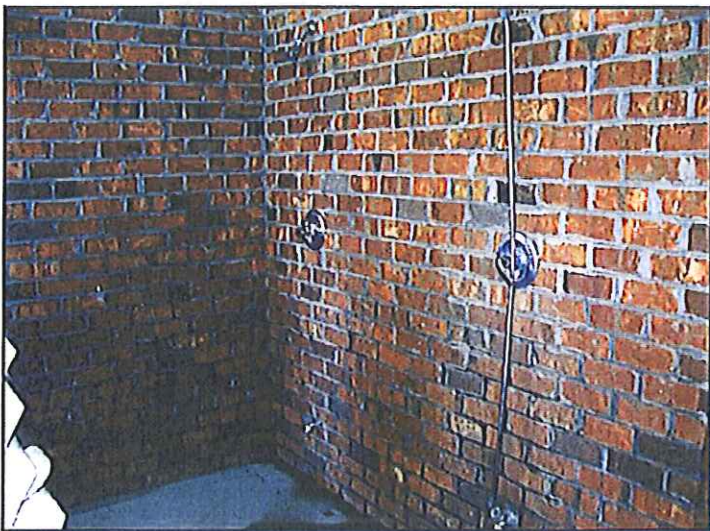
Efflorescence at shower

Note: The Association should fund any clubhouse masonry repairs through the operating budget

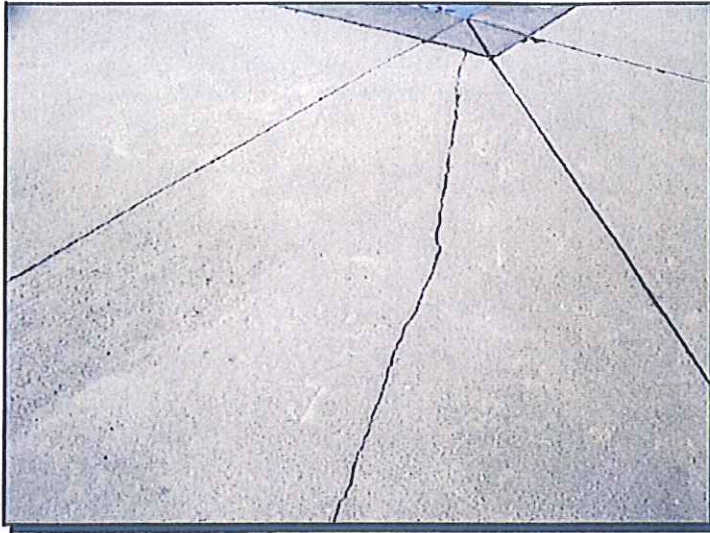
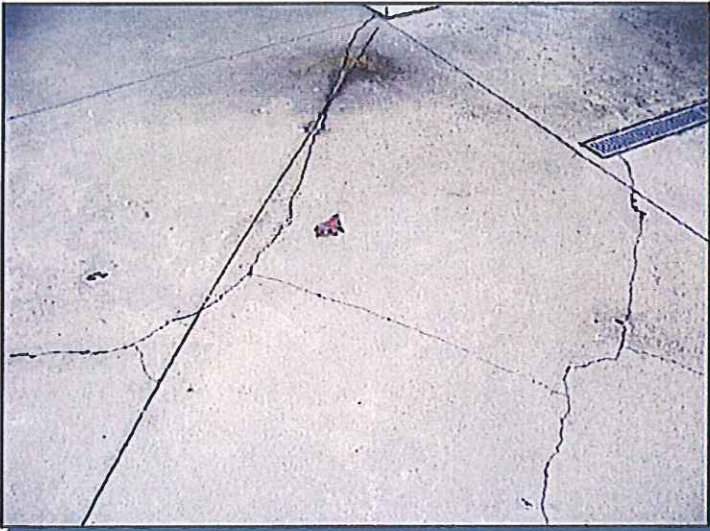
Concrete Deck - A concrete deck surrounds the pool and comprises approximately 7,900 square feet. The deck is original and in good condition. We note several concrete pool deck cracks as shown on Page 5.13 of *Photographs*. The useful life of a concrete pool deck is up to 60 years. However, we recommend the Association conduct inspections, partial replacements and repairs to the deck every 8- to 12-years.

Concrete pool deck crack

Pool deck cracks

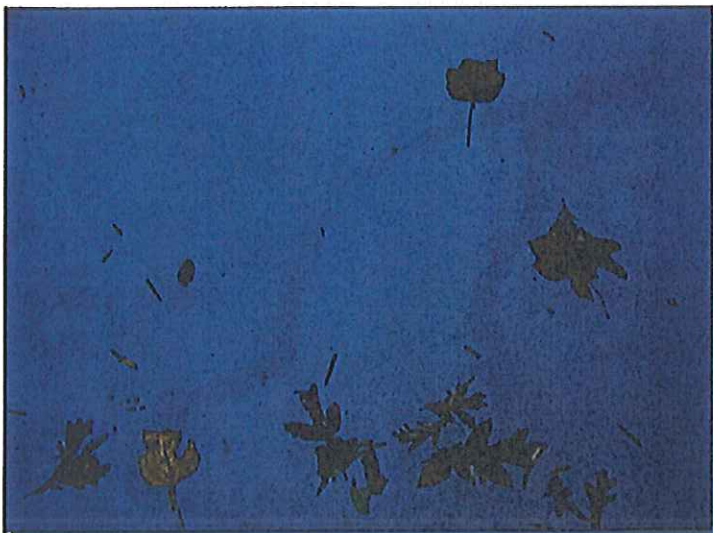
Plaster discoloration and possible granular accumulation
